# Manhole Inspection Summary

Manhole # S33Q\_\_011MH

Insp Date: **3/14/08 10:58 AM**

**Location** Address: **139 hamburg**

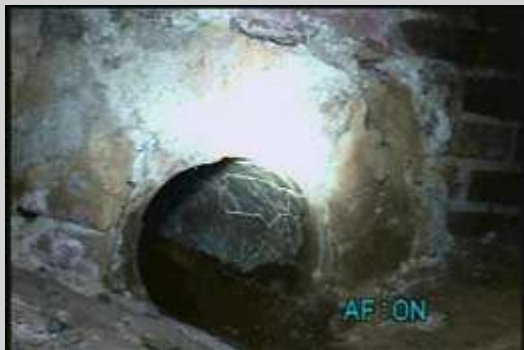
12 O'Clock Outflow

8 in. Circular Gravity Sewer  
Pipe Out @ 12 O'Clock

Infiltration: **None** Pipe Seal Cond: **Unknown**
